# The dome leaks — but it's safe

The futuristic copper-clad dome of the Australian Academy of Science, home to Australian scientific prestige, has been a prominent Canberra landmark since 1958. It's an architectural *tour de force*, but from an engineering view it does have problems.

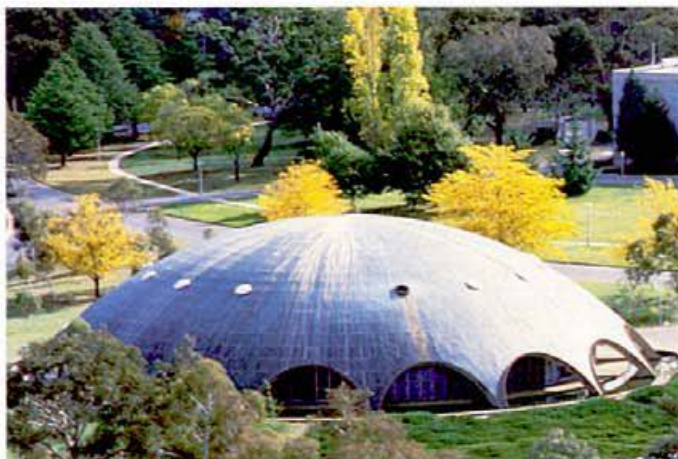
The dome of the Academy of Science — flying saucer or igloo?

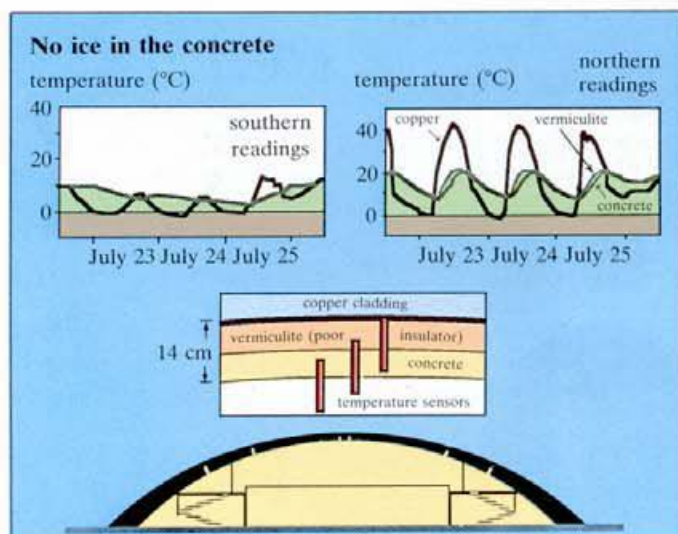
Although the duo recorded 20 nights when the temperature of the outside copper fell below zero, the temperature measured in the concrete — fortunately — never fell below freezing. Its lowest reading was 3°C, at a time when the copper reached -3°C.

Although the temperature of the copper cladding sometimes fell below zero, the scientists' probes showed — reassuringly — that the temperature of the concrete never did.

As long as the Academy can afford to heat the place, at least every few days in winter, freezing of the concrete can be avoided. Ironically, though, if it installs efficient insulation under the concrete shell, reducing heating requirements, the dome's structure may be put at risk.
