Centre for Catchment and In-stream Re

Finding the culprit

Shedding light on seagrasses

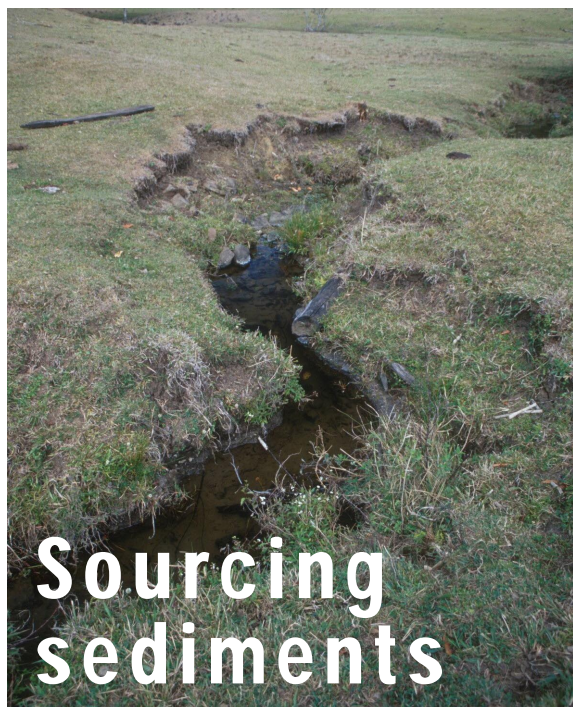
SECRWOMS, 2001

Using SedNet, Prosser modelled the sediment movements for different stretches of river, or 'links' between tributaries. Information on floodplain areas, river widths and levels were used to help produce a map showing the total sediment moving downstream.

'The map showed that the Brisbane and Logan River sub-catchments contribute more than 80% of the total sediment load in Moreton Bay,' Prosser says.

'When you look at a big area like the Moreton Bay catchment, erosion seems such a huge problem. But this map will help to focus management activities on much smaller hotspots.'
